The Sugar River: Farmer-Led Stewardship Drives Progress

Mark Riedel – DNR Project Manager

Health of the Sugar River

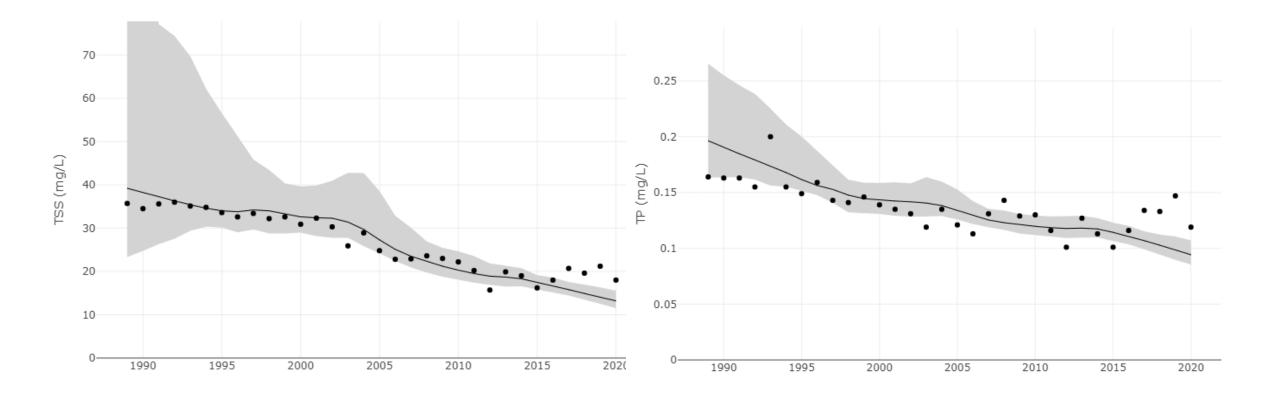
Sugar River Sediment and Phosphorus

(at Brodhead, 530 square miles)

(points are flow-based estimates – grey bars are 75% intervals on observed data)

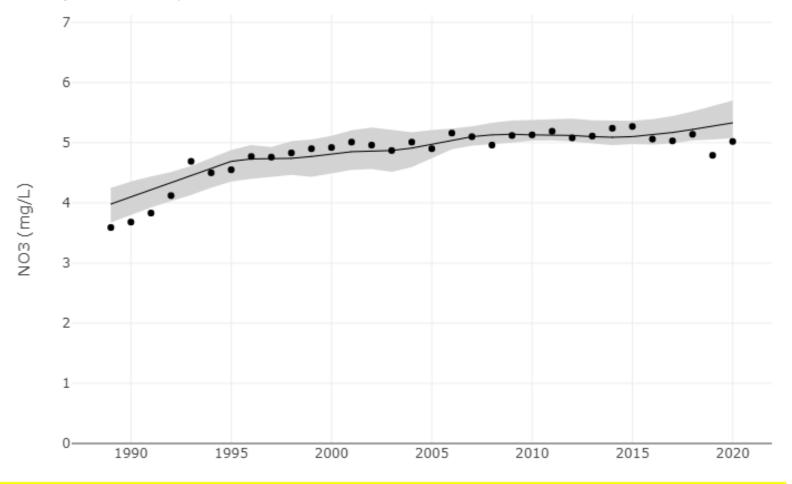
Sugar River Nitrates

(at Brodhead, 530 square miles)

(points are flow-based estimates – grey bars are 75% intervals on observed data)
